Report No. FAA-SS-72-05

**SST Technology
Follow-On Program — Phase I
TITANIUM ALLOYS 6AI-4V
AND
3AI-2.5V HYDRAULIC TUBING**

**D6-60205
July, 1972**

**FINAL REPORT
Task 1**

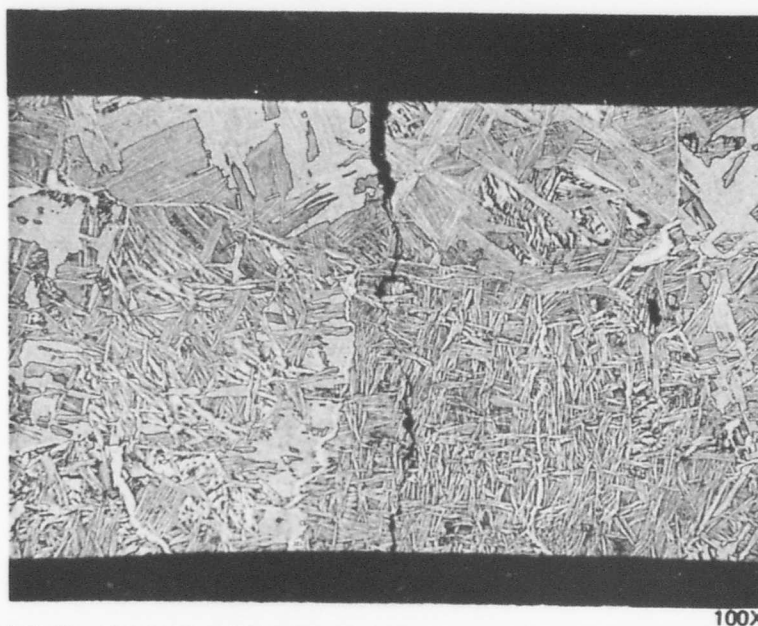
FIGURE 49. —PROFILE OF CRACK SHOWING A COARSE WIDMANSTATTEN STRUCTURE AND A JAGGED FRACTURE

In the referenced report, a circumferential crack formed in Tube 5 and is shown in figure 49. Note the jagged appearance of the crack which is typical in tubing with a Widmanstatten microstructure. It is considered that the major factors which caused early failure, were the Widmanstatten microstructure and excessive wear at the edge of the tube due to fretting beneath a sleeve.

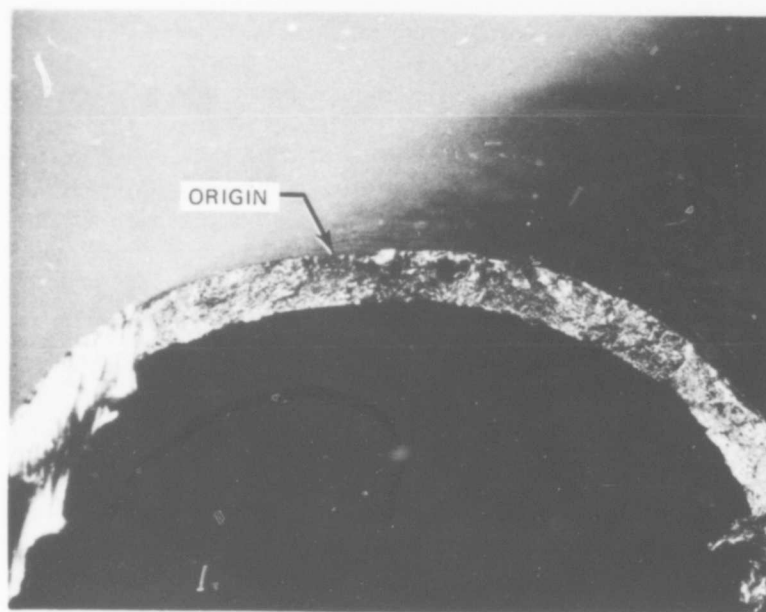
FIGURE 50. —VERY JAGGED FRACTURED SURFACE.

Three failed tubes were examined in this investigation, and all showed a coarse grain Widmanstatten microstructure. The surface of the fatigue cracks were jagged and tended to follow along prior beta grain boundaries as shown in figures 50 and 51. A Widmanstatten microstructure is considered to produce lower tensile properties, including lower ductility, compared to a fine grain equiaxed microstructure. Failure of all three of the subject specimens is attributed to the coarse grain Widmanstatten microstructure, but could also have been affected by small surface defects.

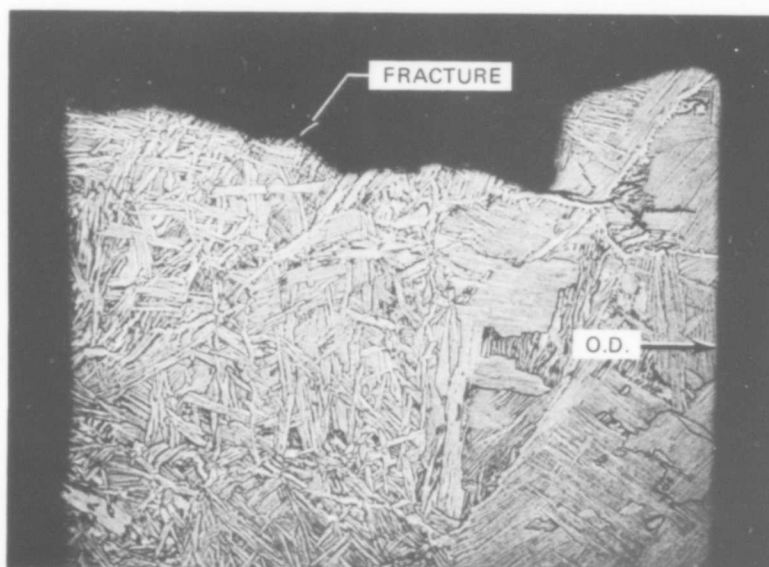
FIGURE 51. —VERY COARSE WIDMANSTATTEN MICROSTRUCTURE, ESPECIALLY TOWARDS THE O.D. ON THE RIGHT—NOTE HOW FRACTURE FOLLOWS ALONG PRIOR BETA GRAIN BOUNDARIES

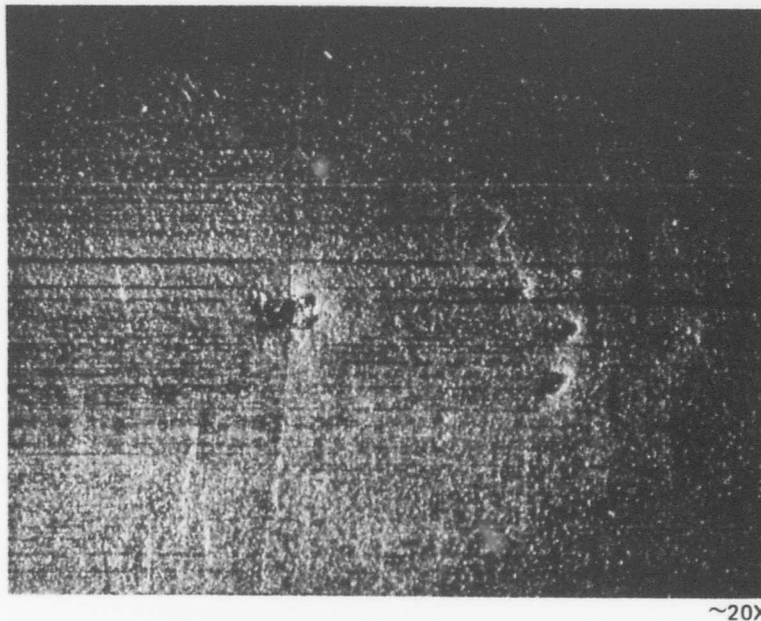
*FIGURE 52.—A PIT TYPE DEFECT WHICH HAS ACTED AS A
FATIGUE CRACK ORIGIN*

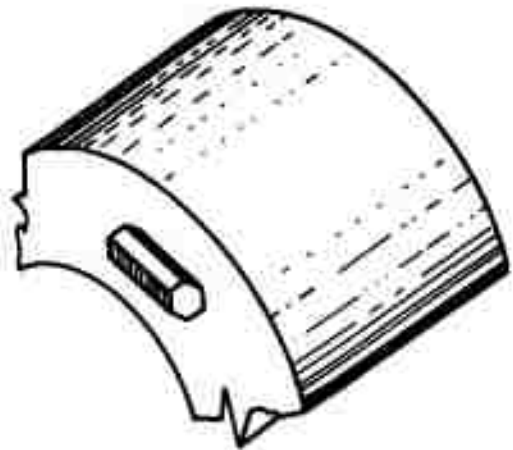
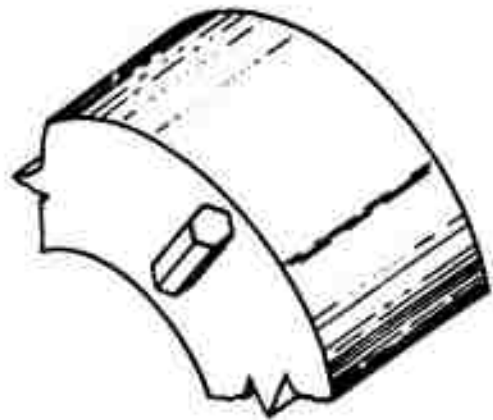
- I.D. Roughness, Longitudinal Defects
- Best hoop strength
- Unit cell tends toward circumferential orientation

- Unit cell tends toward radial orientation
- Resists wall thinning during tension deformation

FIGURE 53.—EFFECT OF PROCESSING ON TEXTURE AND PROPERTIES OF TITANIUM TUBING
